Radiological Surveys at Various Areas Former Naval Station Treasure Island

August 2015 BCT Meeting

Radiological Scanning of Various Areas – Part I

Radiological Scanning of Various Areas – Part II

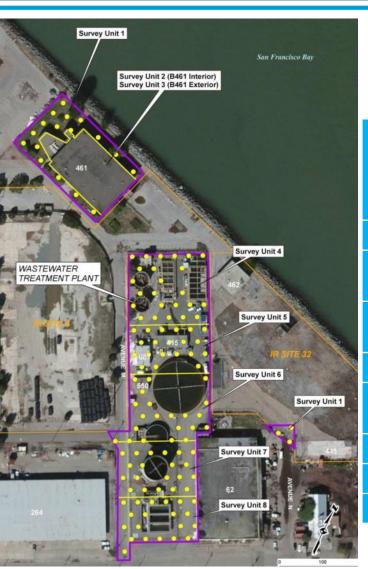
TI Northeast Corner

SU	Surface Material	Scans (% Complete)	Swipe/Soil Samples (% Complete)	Remediation Required (Yes/No)
1	Soil	100%	100%	Results pending
2	Building interior	90*%	90*%	Results pending
3	Building exterior	90*%	90*%	Results pending
4	Asphalt	100%	100%	Results pending
5	Asphalt/ Soil	100%	100%	Results pending
6	Asphalt	100%	100%	Results pending
7	Asphalt	100%	100%	Results pending
8	Asphalt	100%	100%	Results pending

90*% = Scan is 100% complete. Data is being reviewed and additional static measurements may be collected.

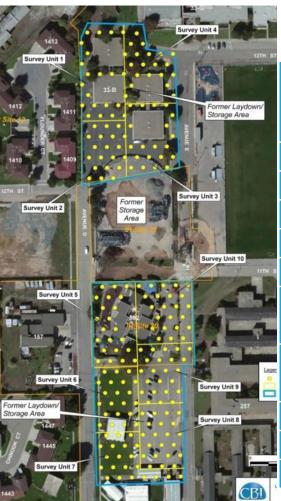
IR Site 30/30N/30S

Scans Samples Requi	
	NO)
1 Asphalt/Soil 100% 100% No)
2 Asphalt/Soil 100% 100% No)
3 Asphalt/Soil 100% 100% No)
4 Asphalt/Soil 100% 100% No)
5 Asphalt 100% 100% No)
Asphalt/Soil/	
6 Concrete 100% 100% No)
Asphalt/Soil/	
7 Concrete 100% 100% No)
8 Asphalt 100% 100% No)
9 Asphalt 100% 100% No)
10 Asphalt 100% 100% No)

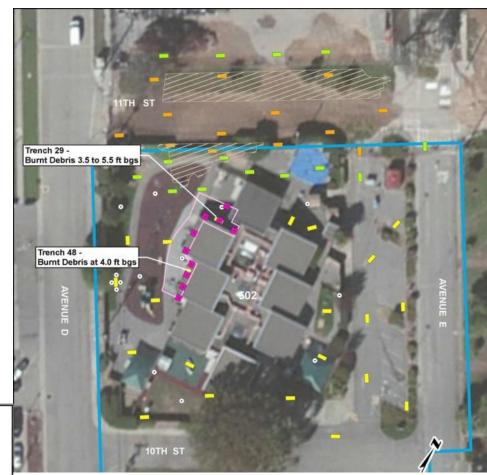
IR Site 30 Debris Investigation

- Ten borings were advanced adjacent to and under Bldg 502
- Two samples were collected per boring and analyzed for gamma spec (Ra-226 and daughters)
- Identified burnt debris in 2 borings, consistent with previous findings
- Final results are below screening criterion

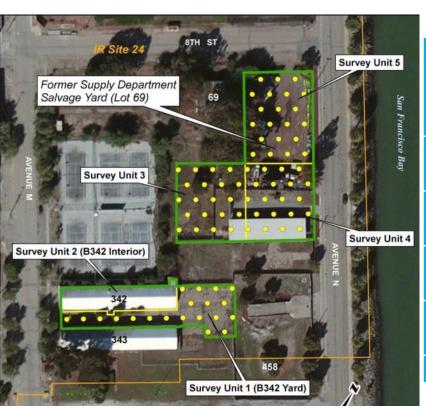
IR Site 24 Areas – Lot 69 and Building 342

SU	Surface Material	Scans (% Complete)	Swipe/Soil Samples (% Complete)	Remediation Required (Yes/No)
1	Asphalt/Soil/ Concrete	100%	100%	No
2	Building interior	100%	100%	No
3	Asphalt/Soil/ Concrete	100%	100%	No
4	Asphalt/Soil/ Concrete	100%	100%	Results pending
5	Asphalt/Soil	100%	100%	No
4	Concrete Asphalt/Soil/ Concrete	100%	100%	Results pending

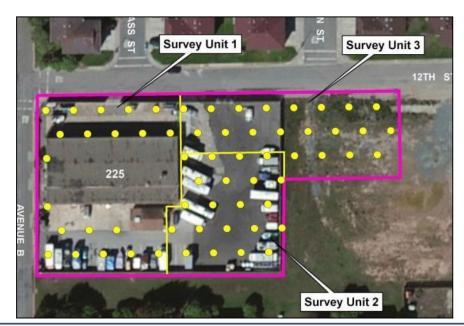
IR Site 20

SU	Surface Material	Scans (% Complete)	Swipe/Soil Samples (% Complete)	Remediation Required (Yes/No)
1	Asphalt	100%	100%	Yes
2	Asphalt	100%	100%	No
3	Asphalt/Soil	100%	100%	No

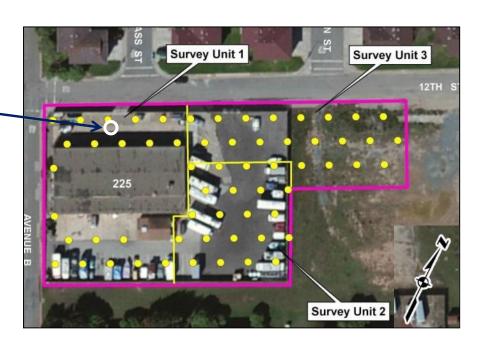
IR Site 20

R	Radium-226 (pCi/g)	
Sample Location	Sample Date	Result (pCi/g)	MDC	Notes
Excavation bottom	7/14/2015	0.755	0.106	
Southwest Wall	7/14/2015	0.438	0.108	
Northeast Wall	7/14/2015	0.574	0.122	
South Wall	7/14/2015	1.86	0.134	Overexcavated/removed on 7/30/2015
South Wall	7/30/2015			Results pending

Above TI screening criterion for Ra-226 (1.69 pCi/g)

Approximate location of remediation

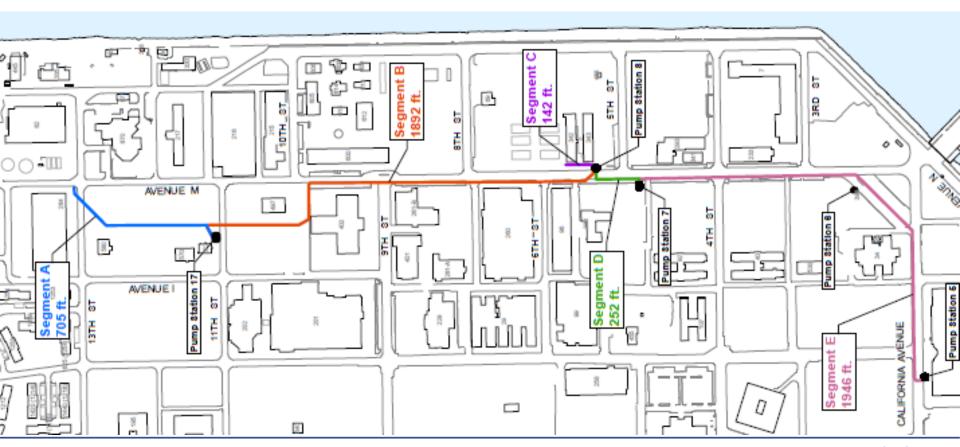
Selected Storm and Wastewater Sewer Lines

- Active Wastewater Lines Along Avenue M
 - -Survey is scheduled for August 12, 19, tentatively for 26

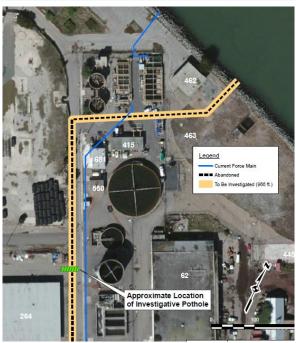
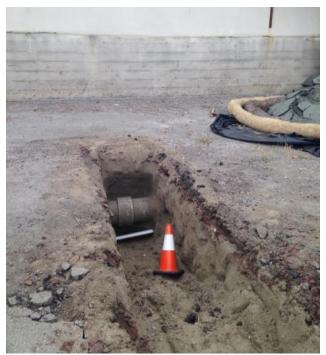
Selected Storm and Wastewater Sewer Lines

- Abandoned Storm Drain Lines near Building 264
 - -Abandoned storm drain not identified

June 30, 2015

July 29, Facing west towards Bldg 264
